## PRE-PURCHASE TIMBER PEST INSPECTION REPORT

Service Order ID:	431228135	Location ID:	431100753
<b>Pre-Inspection Agreement No:</b>	.	<b>Report No</b>	01
Account Client:	Ross Caruso	Client No:	100916
Address of Client:	194 Quinns Hill Road West Satpylton		
Client Post Code:	4207		
Client email:	rosscaruso@msn.com	Client phone	0413297195
Address of property inspected:	338 Scenic Hwy		
Post Code of property inspected:	4703	Date of inspection	21 Sep 2018

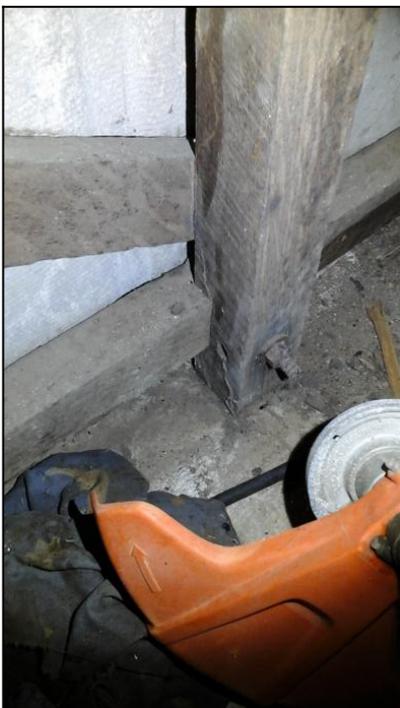
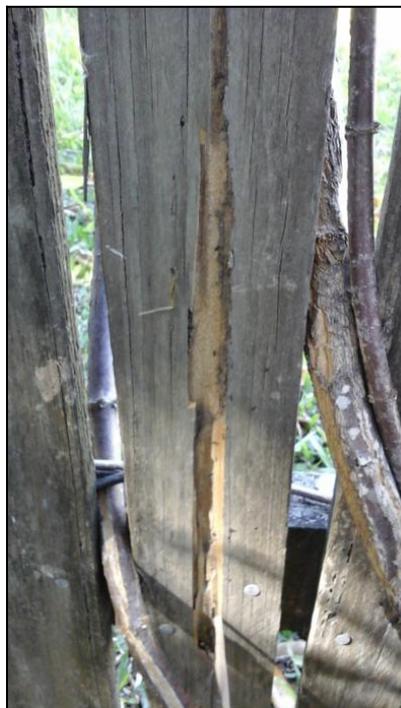
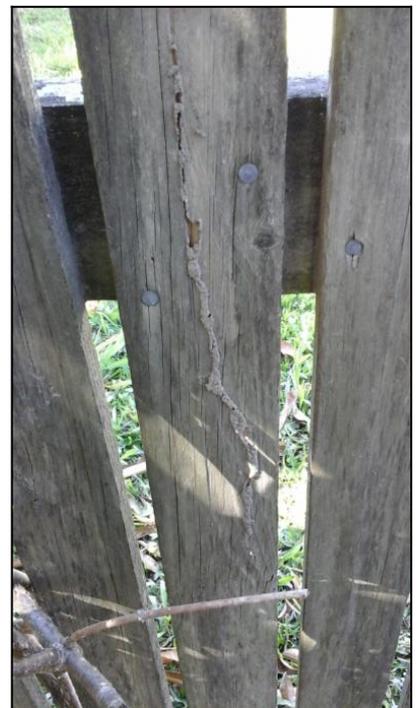
Photo Notes: Photos 1,2,3 termite damage to the timber fence. Photos 4,5,6 termite workings in the shed,.photos 7,8 termite damage to the tree stumps.

Moderately Widespread

Moderate

Have the timber fence panels replaced with nonsusceptible material.

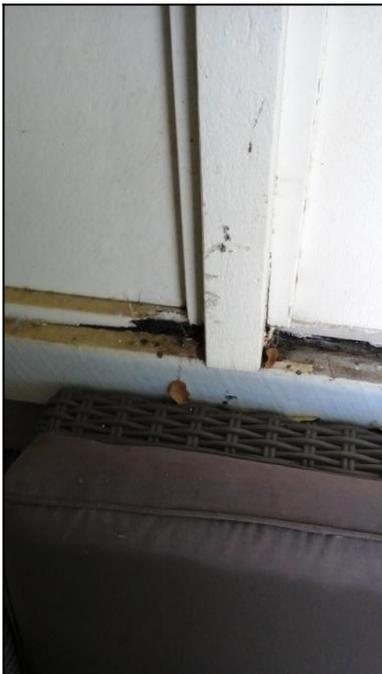
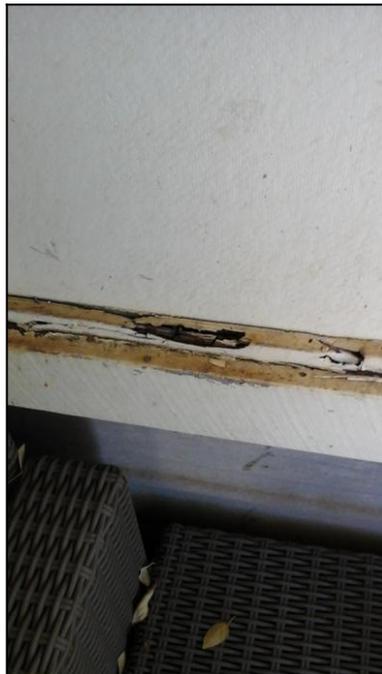
Building Exterior

**Photo Notes: Photos 1,2 rear window frame and dividing wall.**

Have a licensed builder inspect and repair.

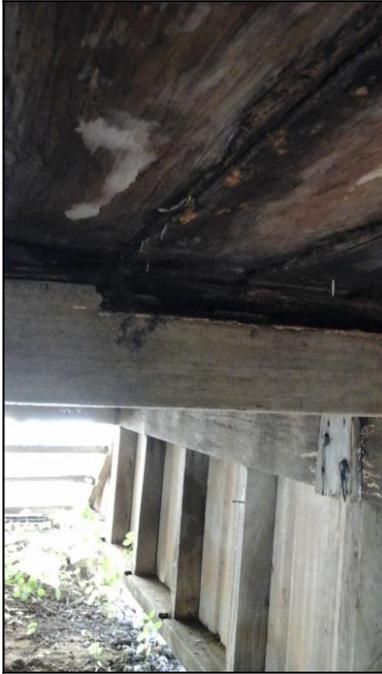
Subfloor Space

**Photo Notes: Under the front patio**

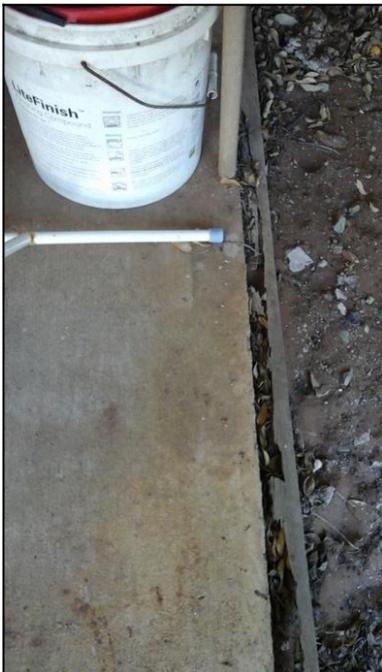
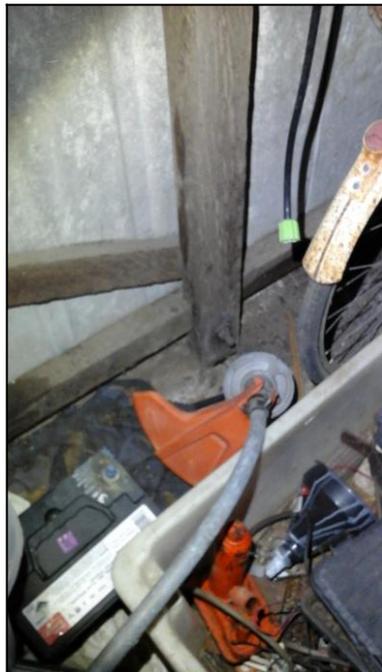
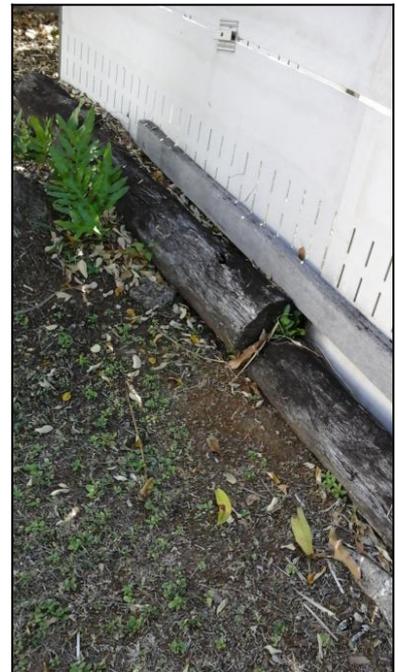
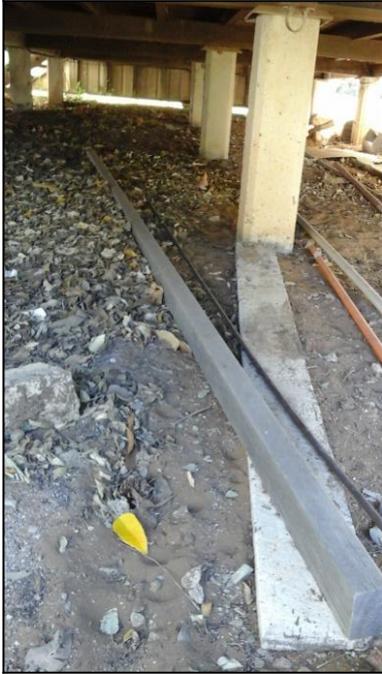
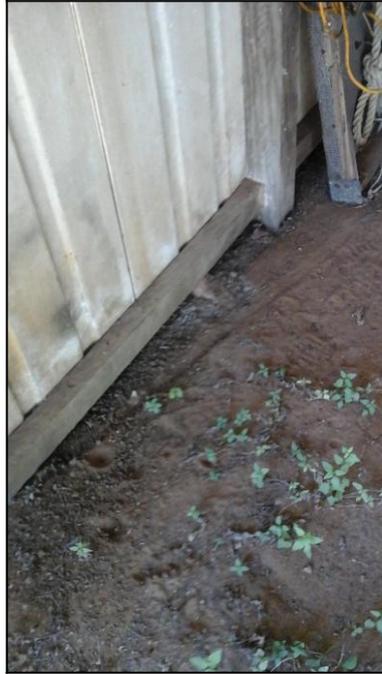
**Photo Notes: Landscaping timbers, timber frame walls in the shed, timber formwork around the edge of the concrete slab for the exterior laundry. Timber debris in the subfloor.**

Remove and replace with nonsusceptible material
