# Pre-Purchase Residential Property Inspection Report

**At:** 1 & 2 / 338 Scenic Highway, Rosslyn

**Date of Inspection:** 21<sup>st</sup> September 2018

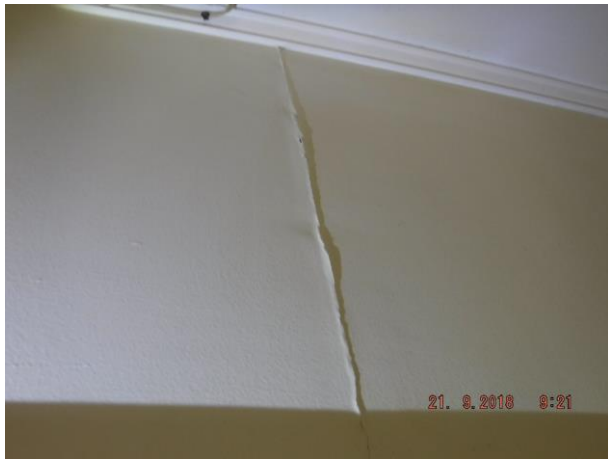
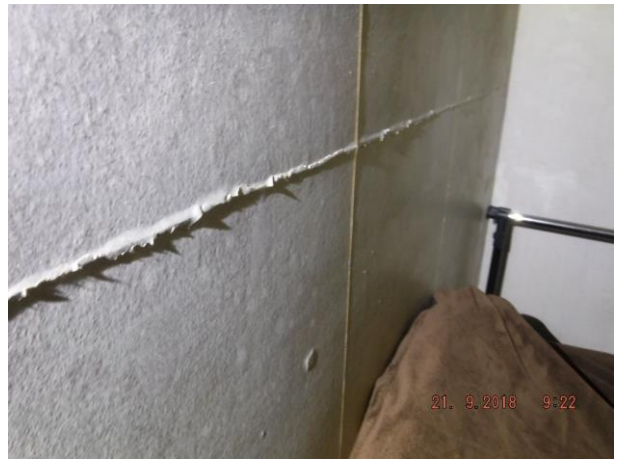
Unit 1 wall linings have some movement cracking – Refer 1.02

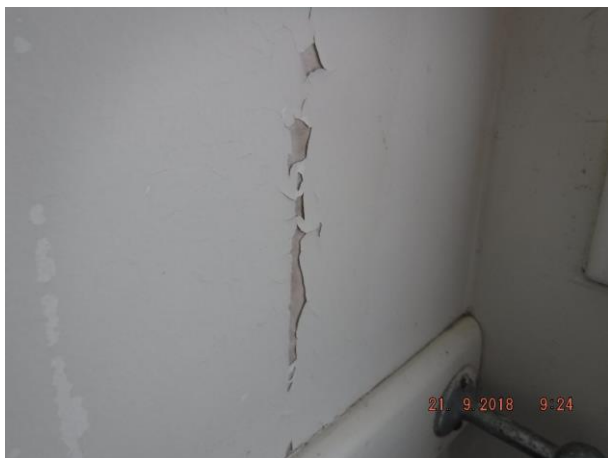
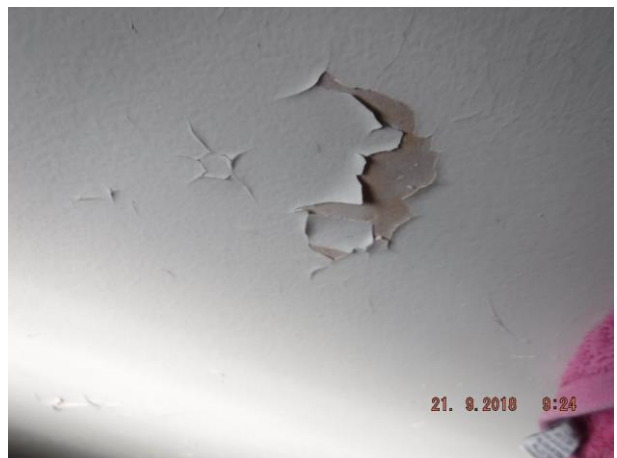
Unit 1 shower walls have moisture damage – Refer 1.02

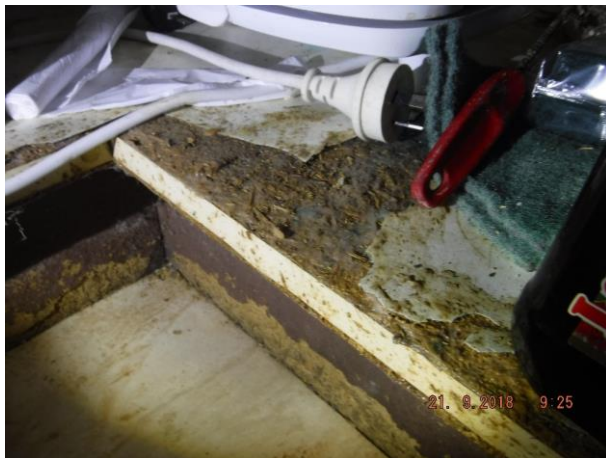
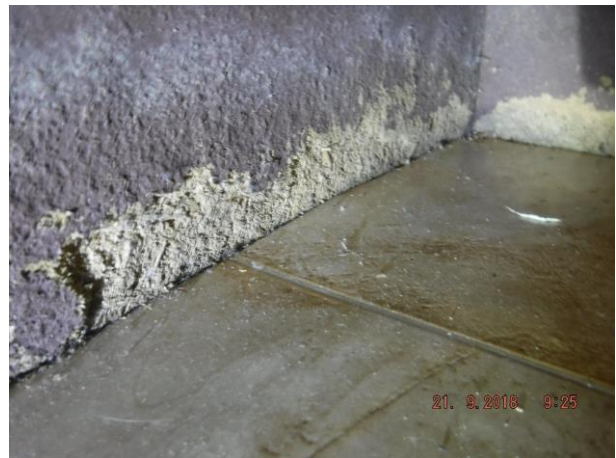
Peeling paint to unit 1 and unit 1 kitchen bench top has gap between top and skirt tile junction – Refer 1.02 and 1.09(a)

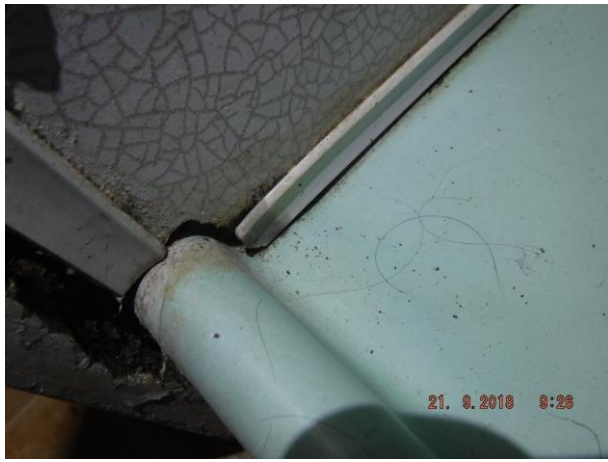
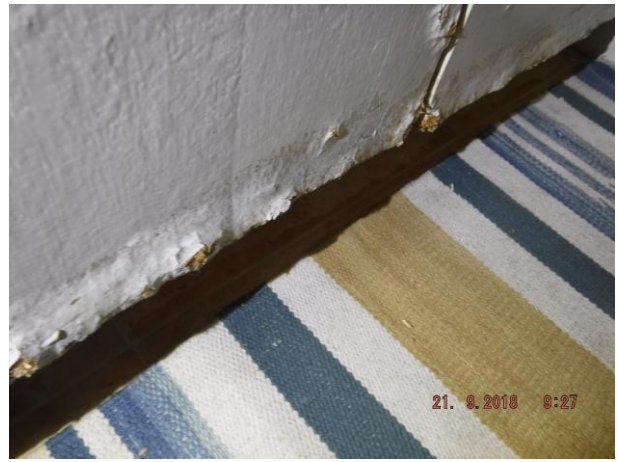
Unit 1 toilet has deteriorated and leaking cistern to pan rubber connector and unit 1 shower cubicle lami panel wall linings are loose to shower tray recess – Refer 1.10(d) and (f)

<b>(f) Bath for example</b> Damage, adequately sealed and at junction with wall, properly recessed	Unit 1 shower cubicle.  Unit 2 shower cubicle.	Poor	Lami panel wall linings are loose to shower tray recess and not sealed at recess junction and steel shower tray is loose to timber cradle. Has previous damp damage repair to north timber wall.	Recommend building maintenance to rectify. Refer photos page 28/29  Recommend invasive inspection.

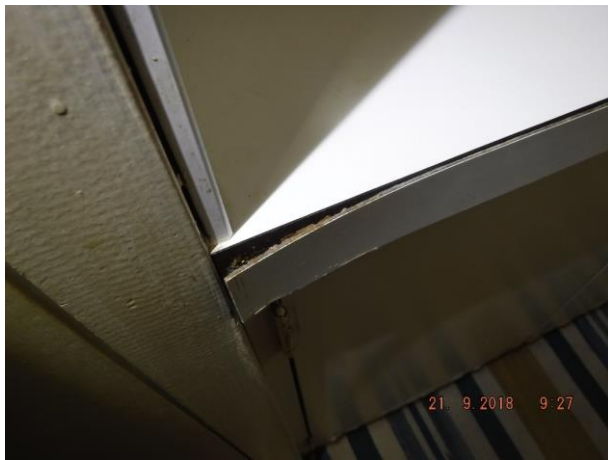
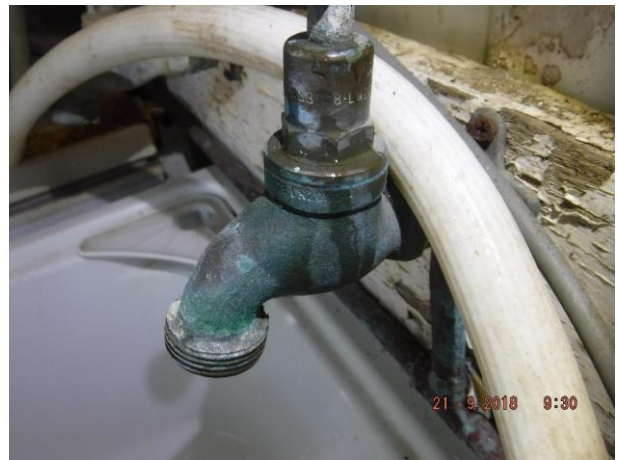
Unit 1 shower cubicle lami panel wall linings are loose to shower tray recess and unit 1 vanity has delaminating shelving and doors – Refer 1.10 (f) and (h)

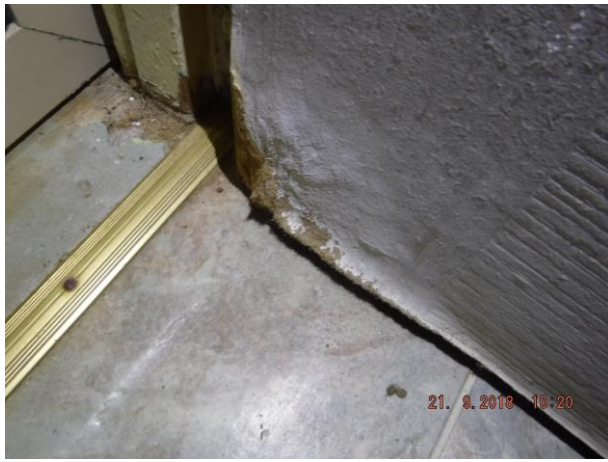
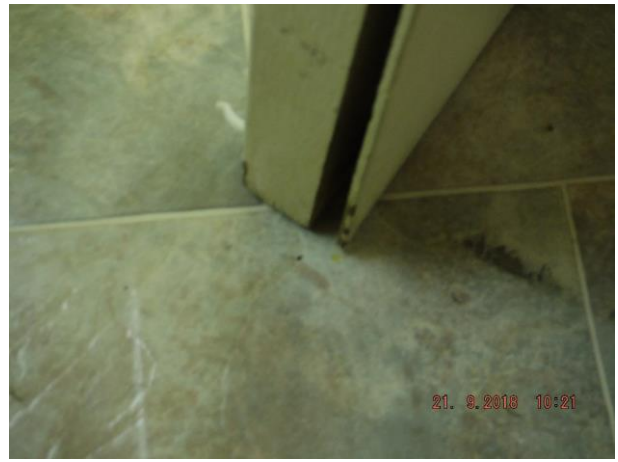
Unit 2 front bedroom double timber doors are damaged and unit 2 rear bedroom door is damaged – Refer 1.07

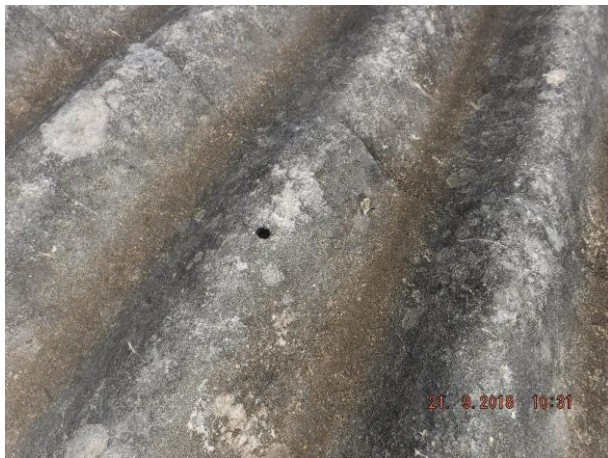
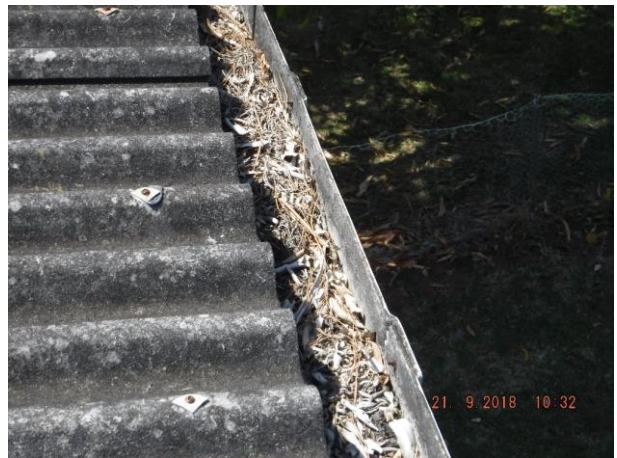
Unit 2 hot water tap is leaking and asbestos roof sheeting and flashings have loose fixings – Refer 1.11(b) and 3.01

- **Roof Exterior:** Asbestos roof sheeting and flashings have corroded, loose and missing fixings. Recommend roof maintenance to rectify. South west vent pipe has no flashing fitted or PVC collar. Recommend roof plumber to rectify.

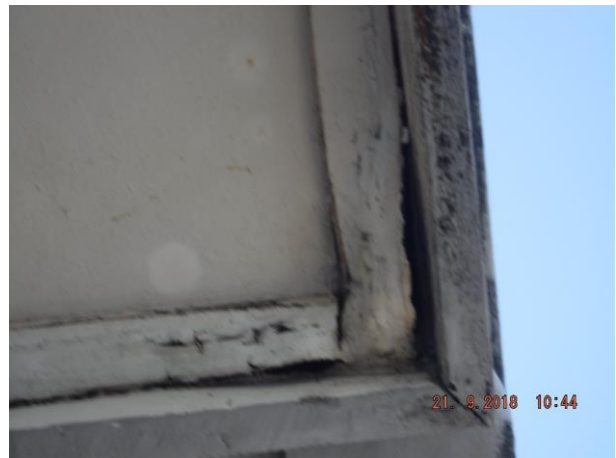
Front and rear gutter joints are cracked and leaking – Refer 3.04

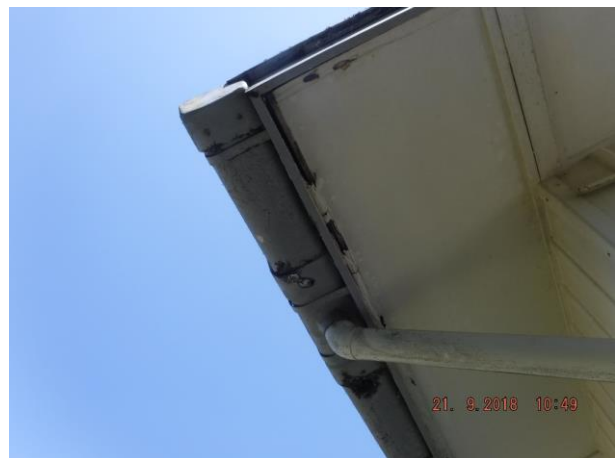
Rear downpipe is missing and south west corner eave has wood decayed timber cover strips – Refer 3.04 and 3.05

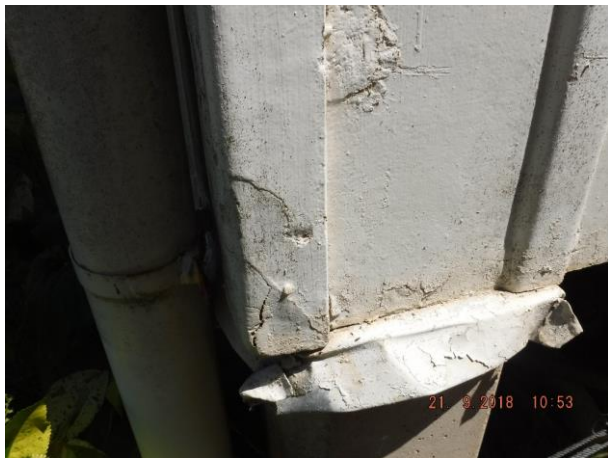
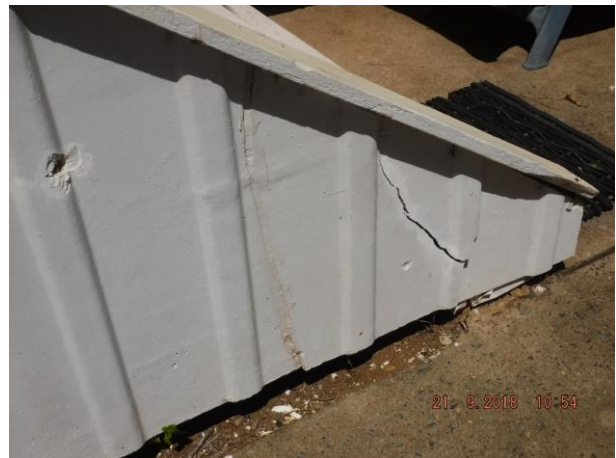
Exterior asbestos wall claddings are significantly cracked and broken – Refer 2.03

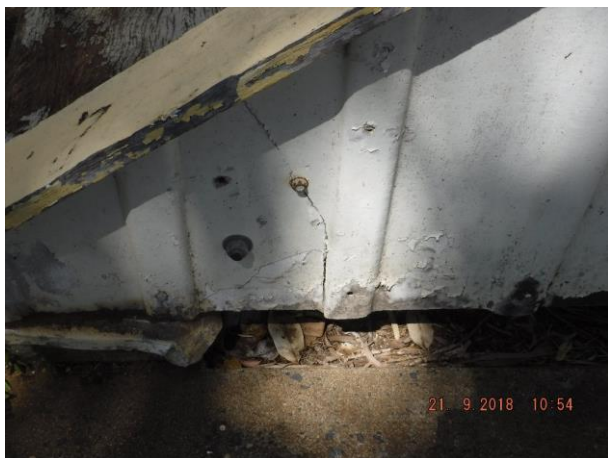
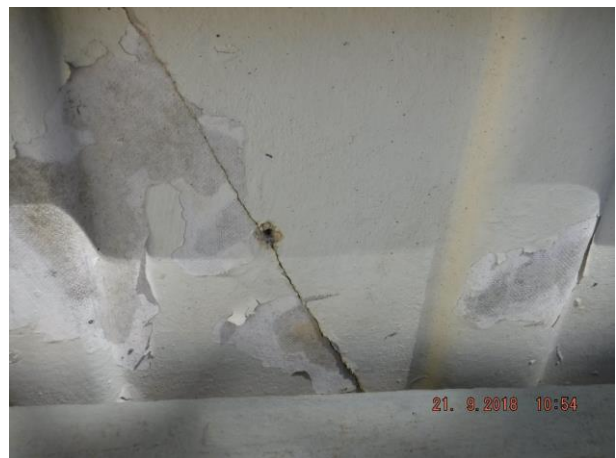
Exterior asbestos wall claddings are significantly cracked and broken – Refer 2.03

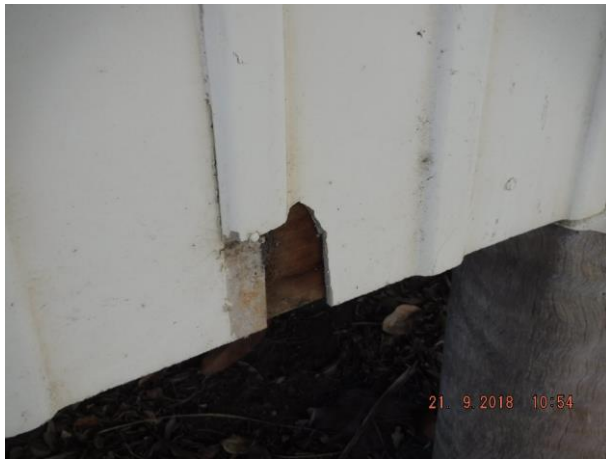
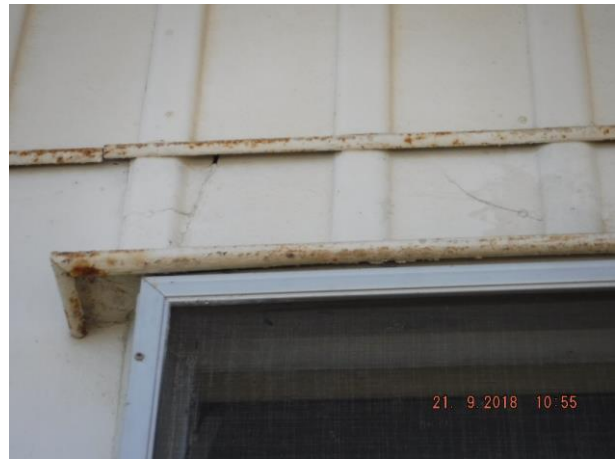
Exterior asbestos wall claddings are significantly cracked and broken – Refer 2.03

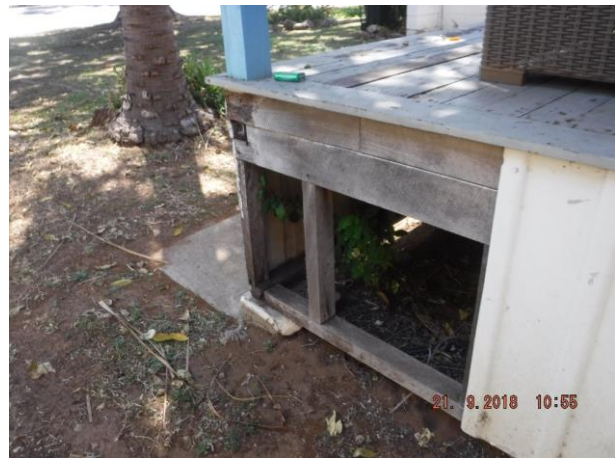
Exterior asbestos wall claddings are significantly cracked and broken – Refer 2.03

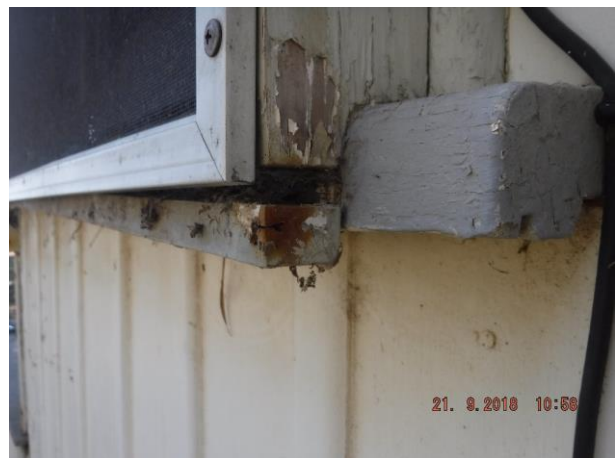
Exterior asbestos wall claddings are significantly cracked and broken and some missing sheeting – Refer 2.03

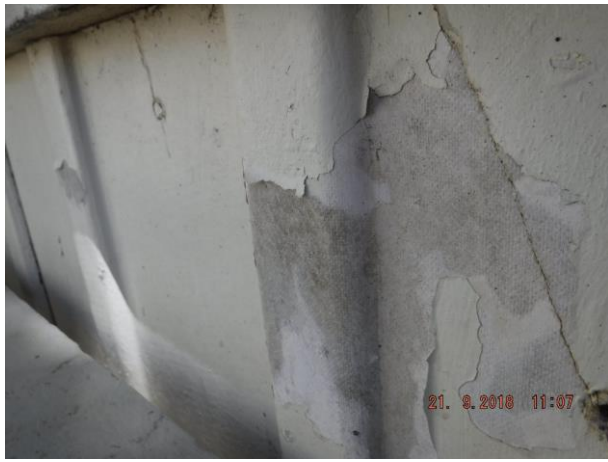
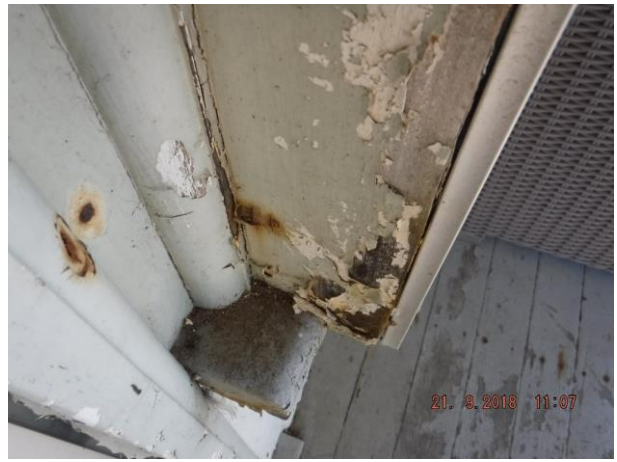
Exterior timber boxed fly screen frames have some wood decay and loose and corroded fixings – Refer 2.07

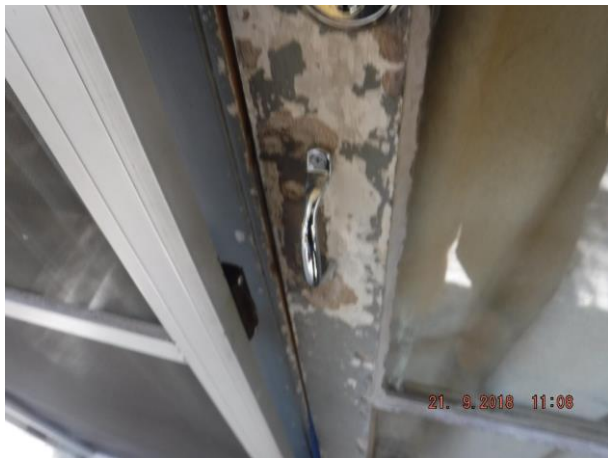
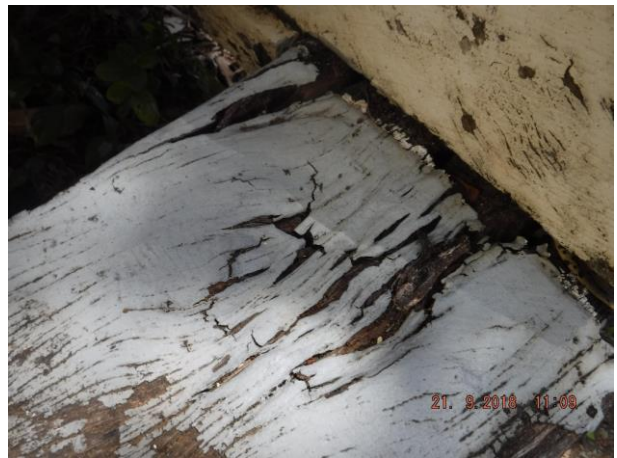
Exterior of duplex has peeling paint from wall claddings, balcony timbers, doors and trims – Refer 2.08

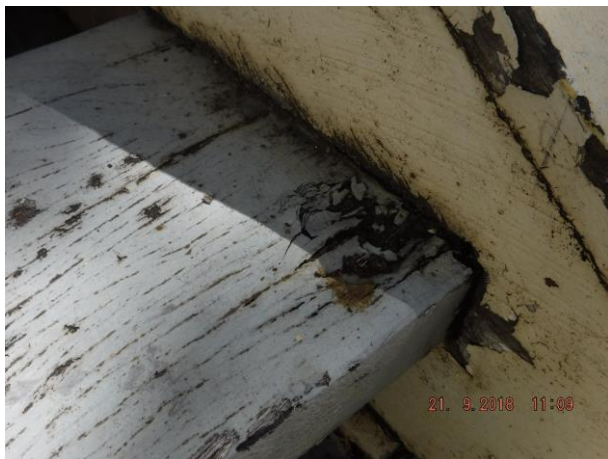
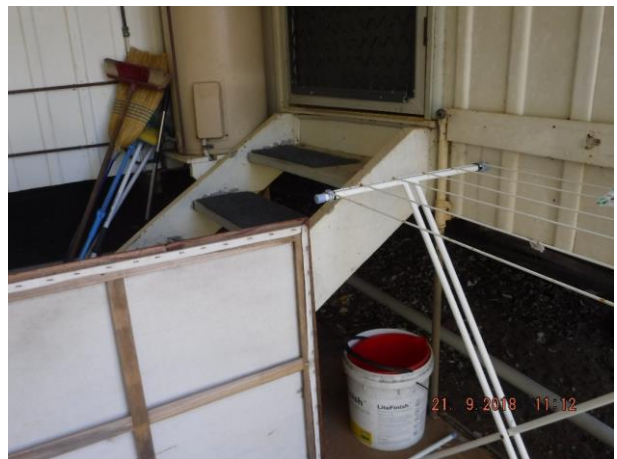
Exterior of duplex has peeling paint from wall claddings, balcony timbers, doors and trims and unit 2 front timber stairs bottom tread has significant wood decay – Refer 2.08 and 2.10

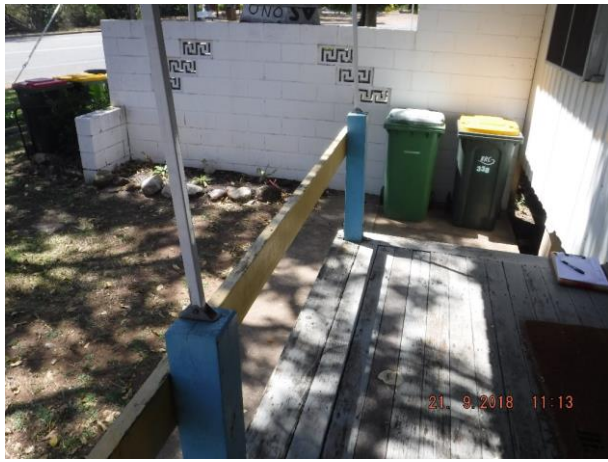
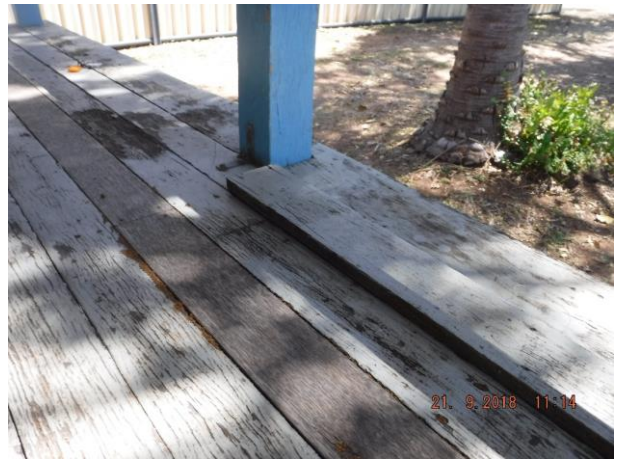
Unit 2 front timber stairs bottom 2<sup>nd</sup> tread has significant wood decay and unit 1 rear timber stairs has no handrail fitted to outside of stairs – Refer 2.10

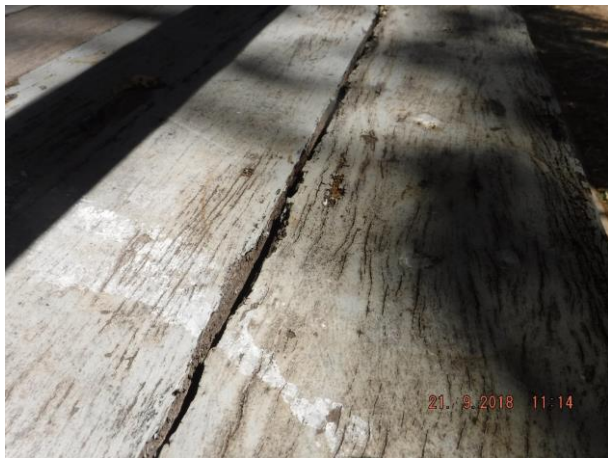
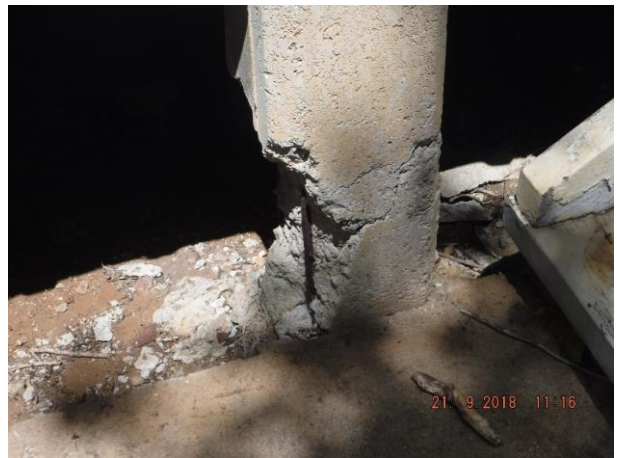
Front balcony handrail newel posts are loose to subfloor timbers and has some loose floor boards – Refer 2.11

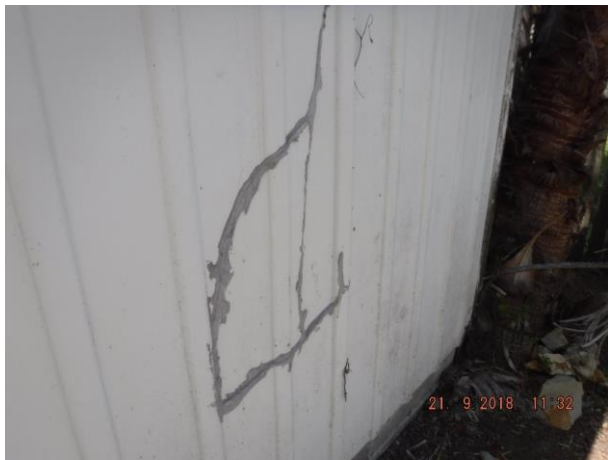
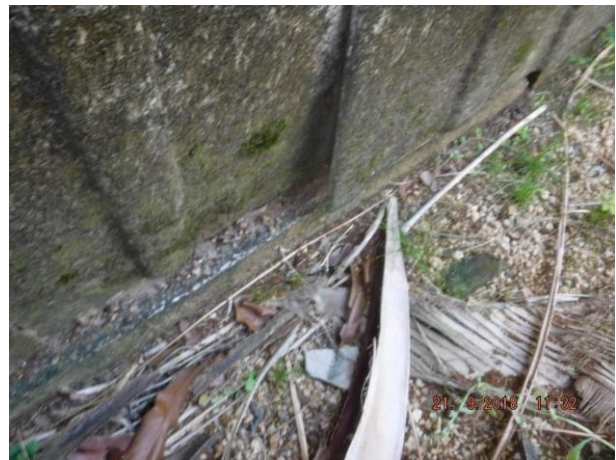
Laundry separating wall has had previous minor termite entry and damage and rear shed has defective sheeting  
Refer 5.03 and 6.04

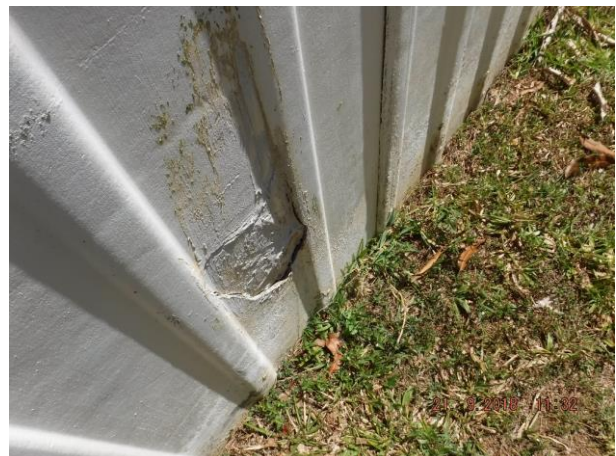
Rear shed has defective sheeting – Refer 6.04

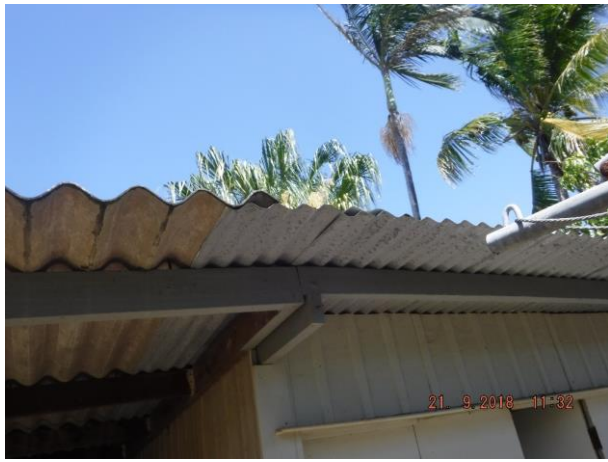
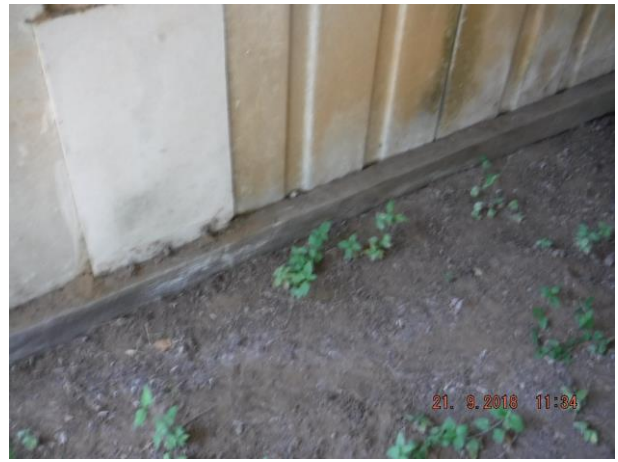
Rear shed has defective sheeting – Refer 6.04

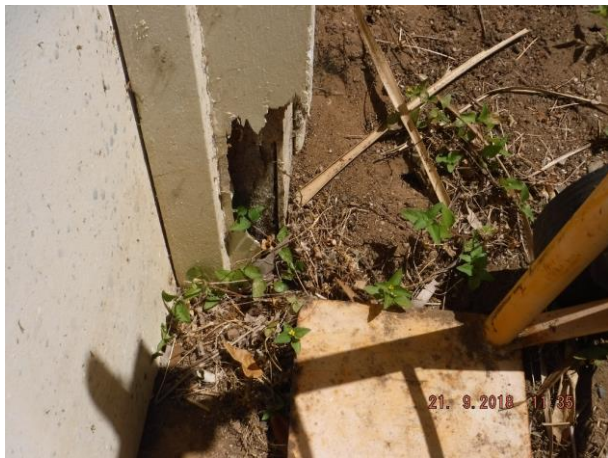
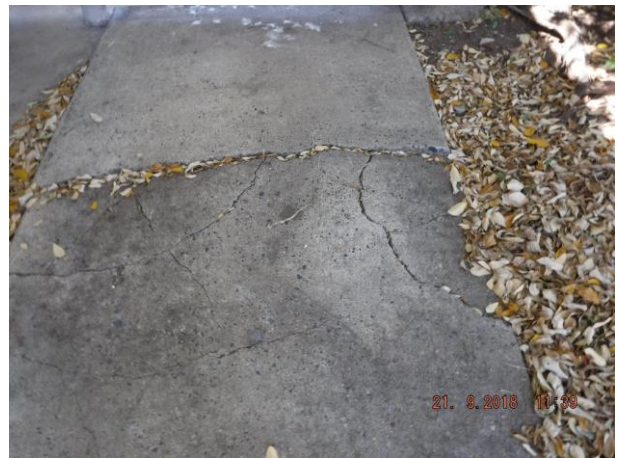
6.02 Detached laundry		N/A		
6.03 Ablution facilities		N/A		
6.04 Garden sheds	Rear shed.	Poor	Defective sheeting. Defectively lapped sheeting. Timber frame encased in ground allowing vermin entry and has previous termite damage.	Recommend building maintenance to rectify. Recommend building permit check for structure. Refer photos page 39/40

Rear shed has defectively lapped sheeting and timber frame encased inground allowing vermin entry – Refer 6.04
