RURAL PROPERTY VALUATION
IRRIGATED LAND & STRUCTURES ONLY
EXCLUDING AVOCADO TREES
ARMIN'S FARM – MULTIPLE LOTS IN ONE LINE ASSESSMENT
700 ADIES ROAD, ISIS CENTRAL QLD 4660

Prepared For
Purpose
Our Reference
Inspection Date
Valuation Date
Issue Date

Lachlan Donovan on behalf of Lad Property (Superfund) Pty Ltd
Asset Management & Financial Reporting Purposes
Eval.18623
20/07/2023
As at 30/06/2023
03/08/2023

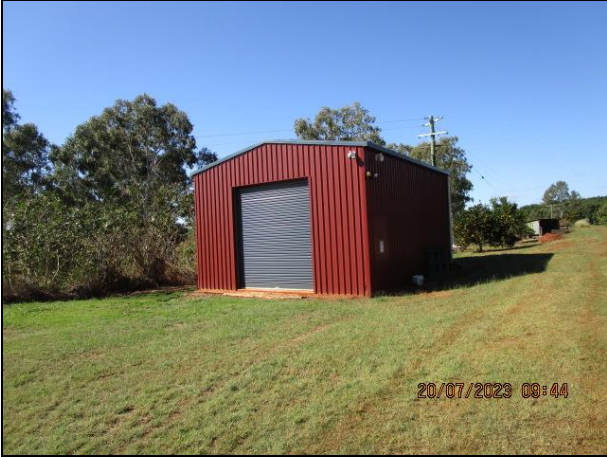
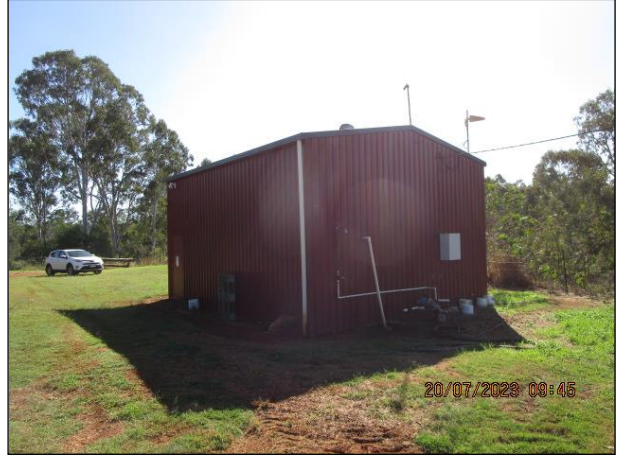
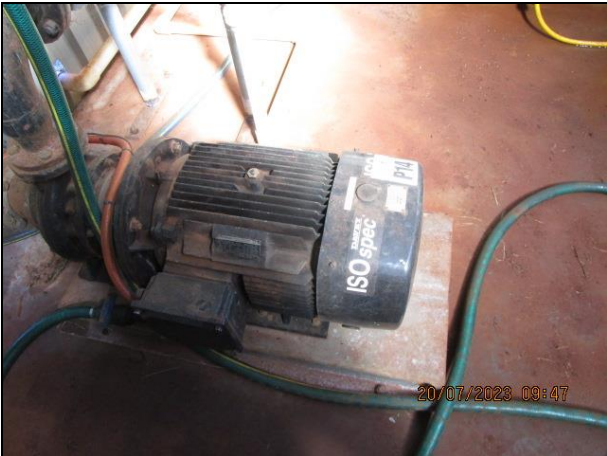
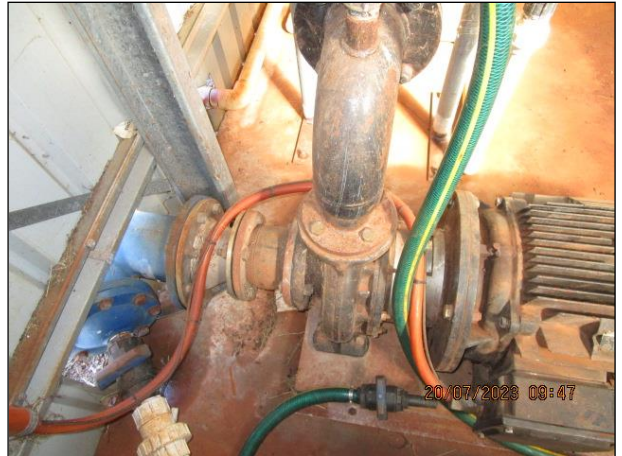
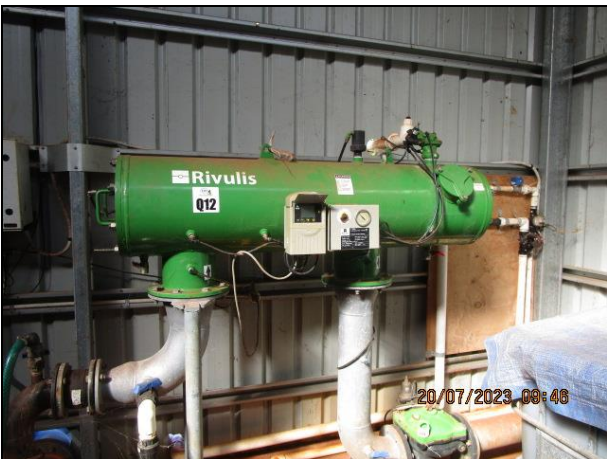
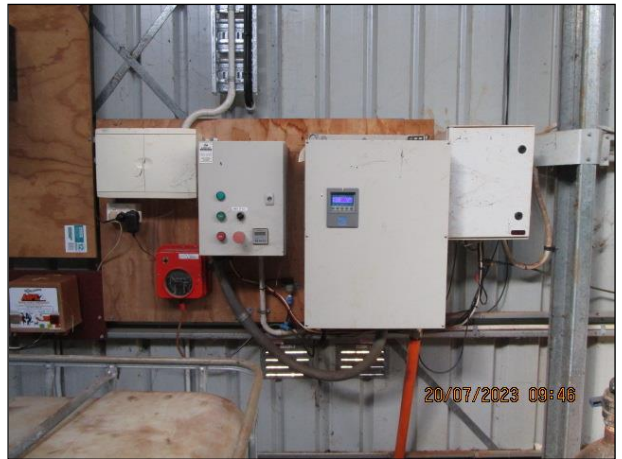
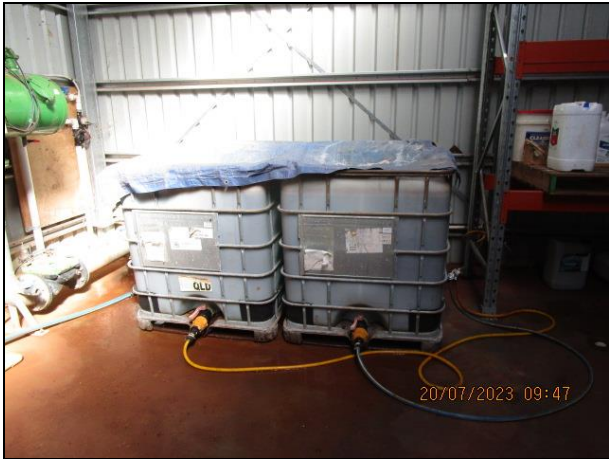
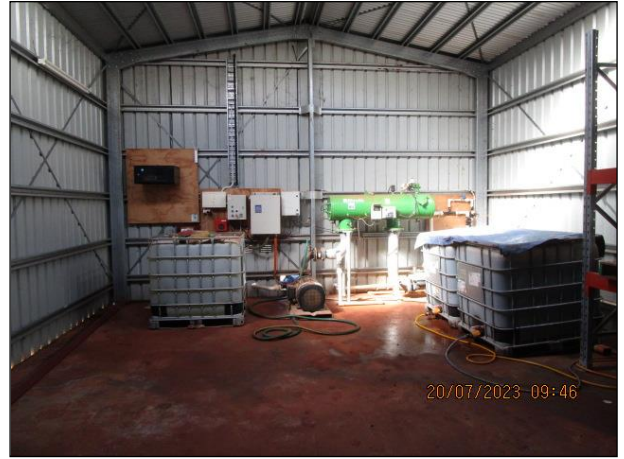
Surface Water Outlet

Located in the northern areas of the holding. Pumping facilities include a Marathon 50kw 3-phase induction electric motor being coupled to a Davey Iso Spec centrifugal pump. This facility also incorporates a variable speed drive, Rivulis PD automatic backflush filter, power board, electric starter, Murphys switch gauge and 3 x liquid fertigation tanks with associated injection and agitation motors. All pumping / filtration and fertigation facilities are housed in a colorbond shed (8m x 6.5m – standard construction with lights and power connected).

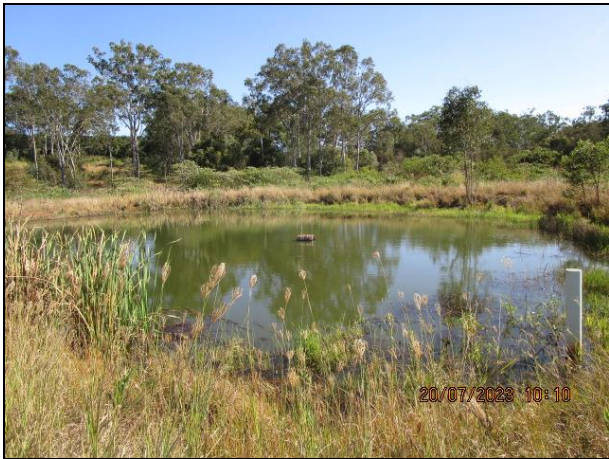
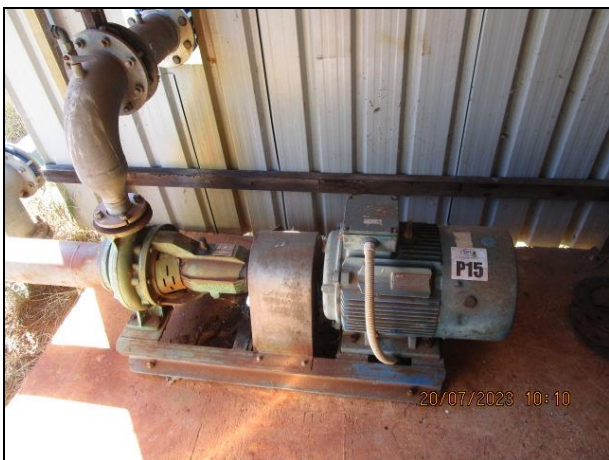
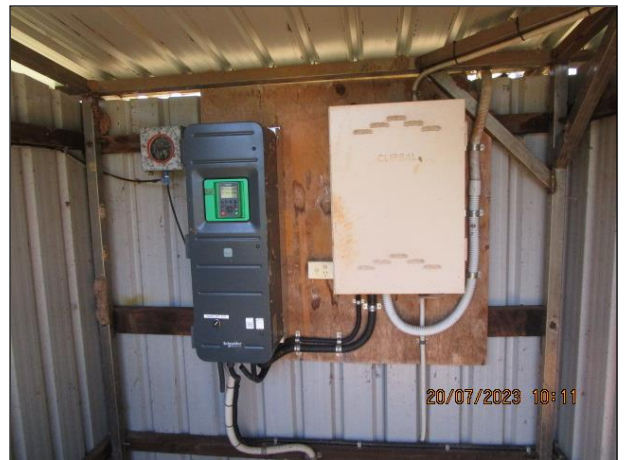
Dam Pump Station

Pumping facilities include a Monarch 22kw 3-phase induction electric motor being coupled to a Southern Cross centrifugal pump. This facility also incorporates a variable speed drive, power board, electric starter and Murphys switch gauge. All pumping facilities are contained within a basic metal clad pump shed.
