# Pre-Purchase Residential Property Inspection Report

**At:** 1 & 2 / 338 Scenic Highway, Rosslyn

**Date of Inspection:** 21<sup>st</sup> September 2018

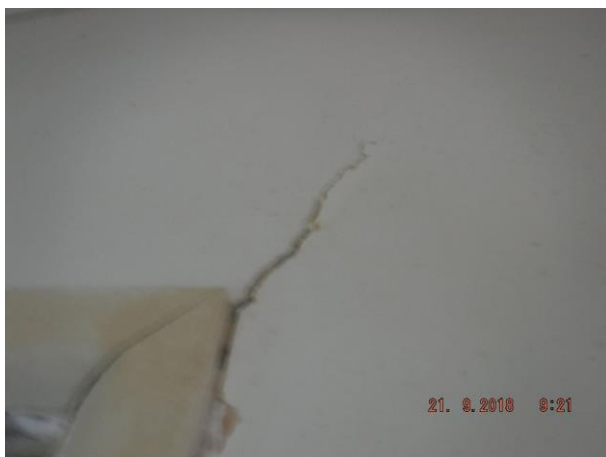
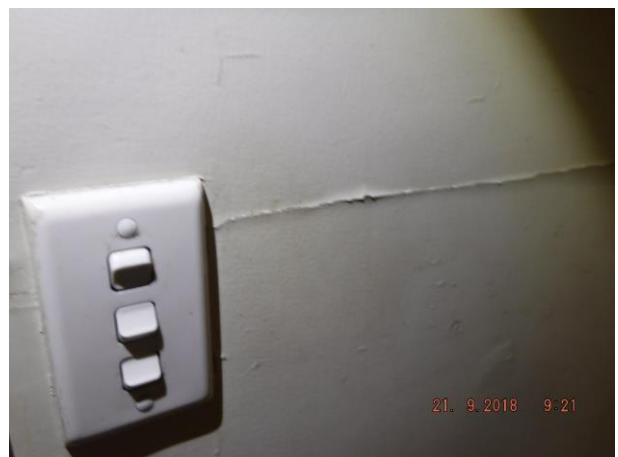
Unit 1 wall linings have some movement cracking – Refer 1.02

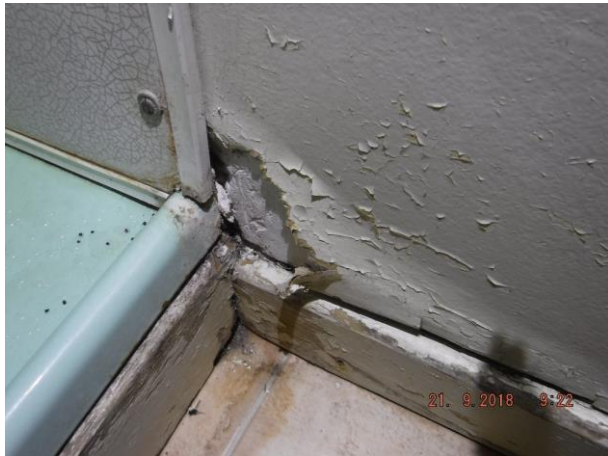
Unit 1 shower walls have moisture damage – Refer 1.02

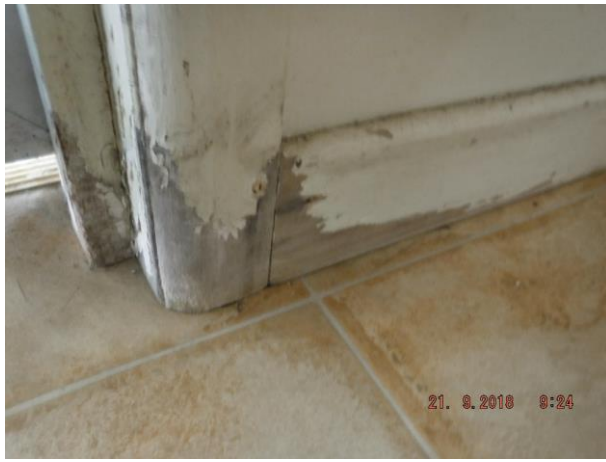
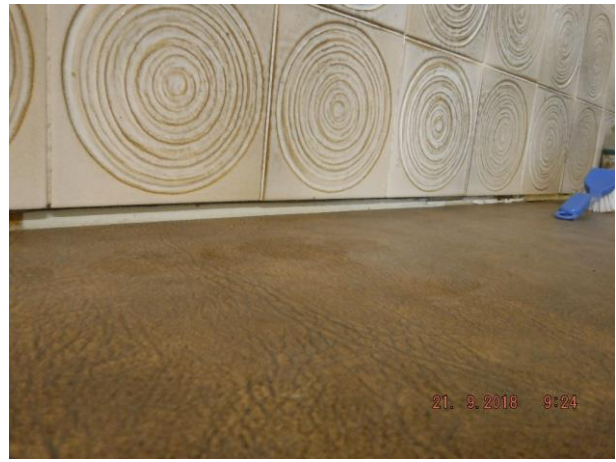
Peeling paint to unit 1 and unit 1 kitchen bench top has gap between top and skirt tile junction – Refer 1.02 and 1.09(a)

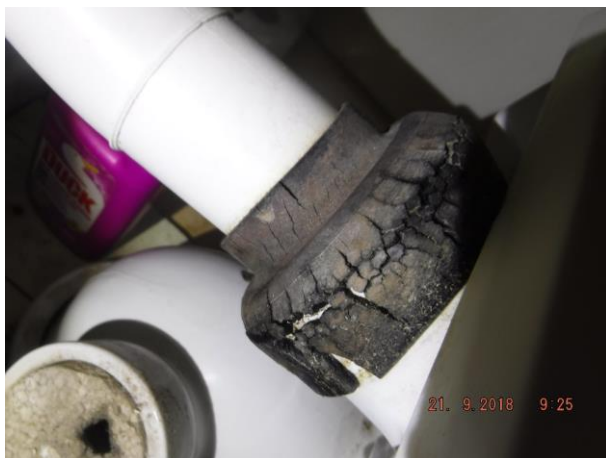
Unit 1 toilet has deteriorated and leaking cistern to pan rubber connector and unit 1 shower cubicle lami panel wall linings are loose to shower tray recess – Refer 1.10(d) and (f)

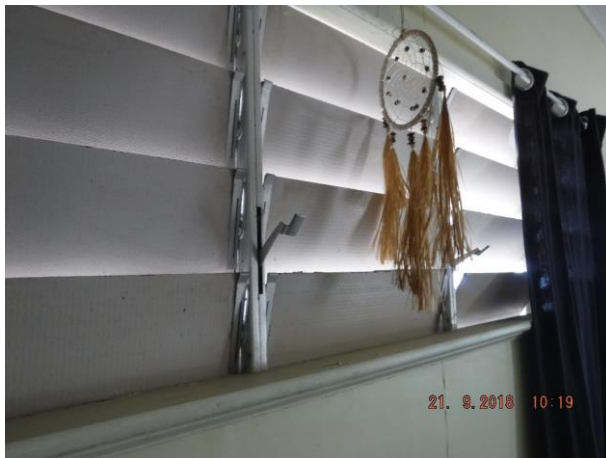
Unit 2 lounge west window has fibro used to galleries instead of glass and unit 2 fly screen door to entry is heavily corroded – Refer 1.06 and 1.07

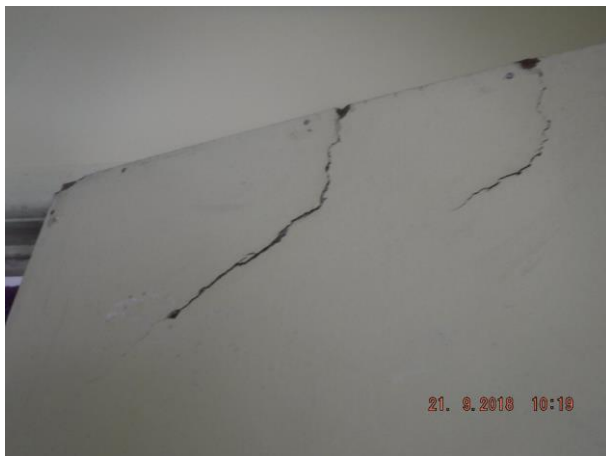
Unit 2 front bedroom double timber doors are damaged and unit 2 rear bedroom door is damaged – Refer 1.07

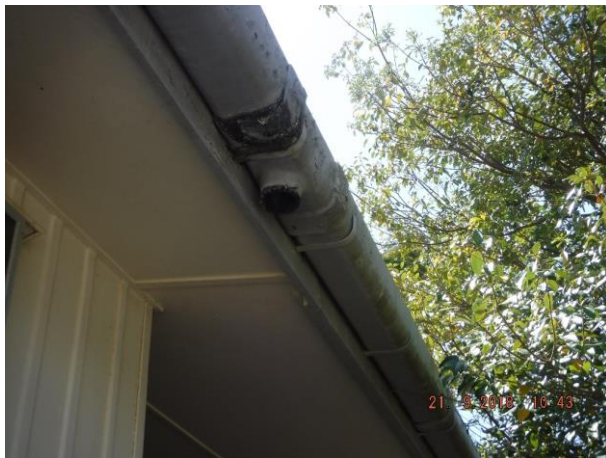
Rear downpipe is missing and south west corner eave has wood decayed timber cover strips – Refer 3.04 and 3.05

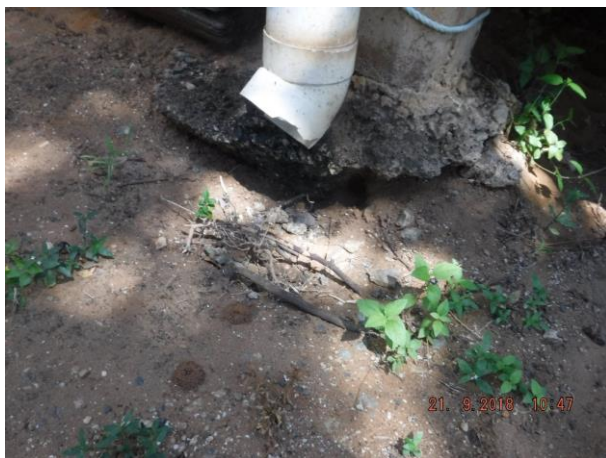
Front east side downpipe is starting to undermine concrete stump footing and rear south east eave is moisture damaged – Refer 3.04 and 3.05

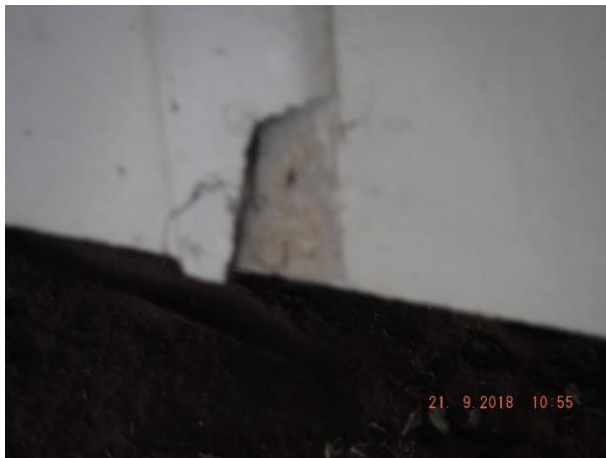
Exterior asbestos wall claddings are significantly cracked and broken and some missing sheeting – Refer 2.03

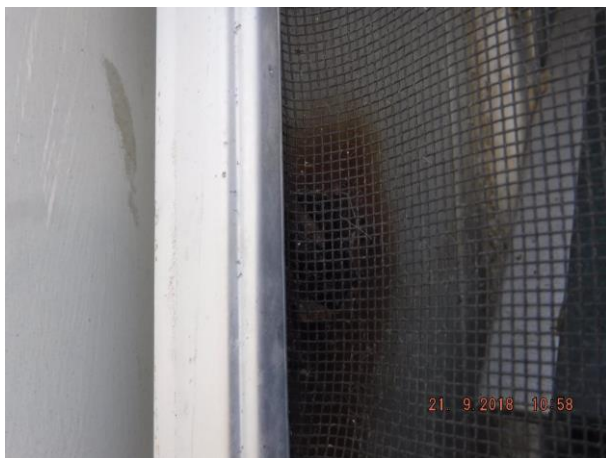
Exterior timber boxed fly screen frames have some wood decay and loose and corroded fixings – Refer 2.07

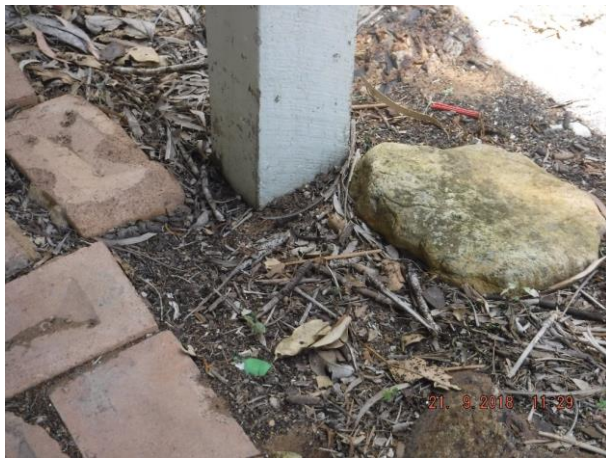
Unit 2 carport timber support post encased in ground and corroded roof sheeting – Refer 6.01

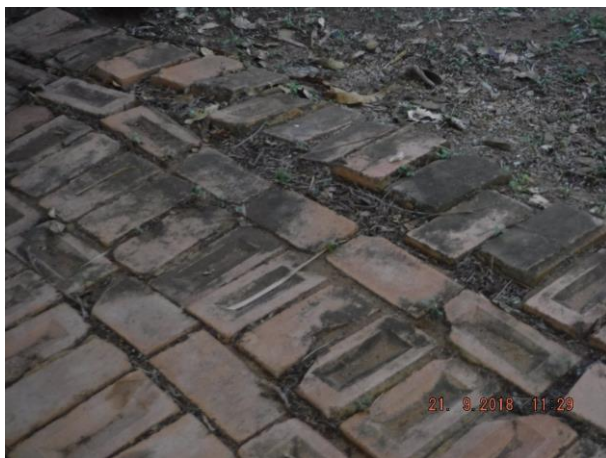
Defective brick paved floor to unit 2 carport and laundry separating wall has had previous minor termite entry and damage  
Refer 6.01 and 5.03

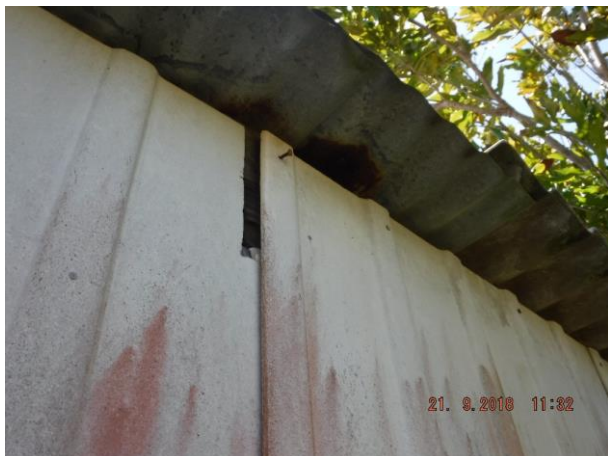
Rear shed has defective sheeting – Refer 6.04
